NASA SAFETY CENTER

SYSTEM FAILURE CASE STUDY

Escape to Failure

The Qantas Flight 32 Uncontained Engine Failure

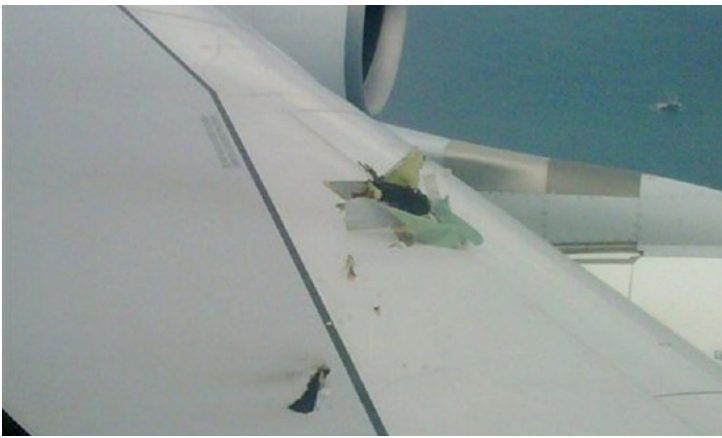
Figure 1. Passengers aboard Qantas Flight 32 documented the damage to the port wing via mobile phone cameras. Source: ATSB

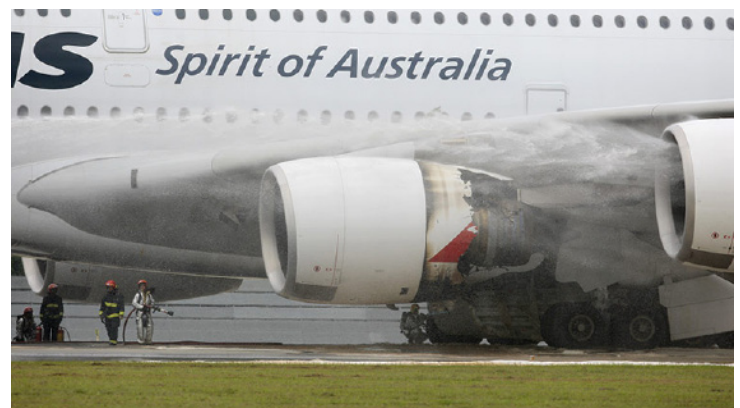
Upon initial inspection, investigators from the Australian Transportation Safety Bureau (ATSB) determined that the No. 2 engine sustained an uncontained failure in the turbine region; liberated engine components then damaged the airframe and systems. While some systems sustained direct mechanical damage, most affected systems were compromised from damage to their wiring assemblies.

Figure 2. Firefighting crews douse the No. 1 engine. The sheared No. 2 engine turbine housing is pictured center frame. Source: ATSB

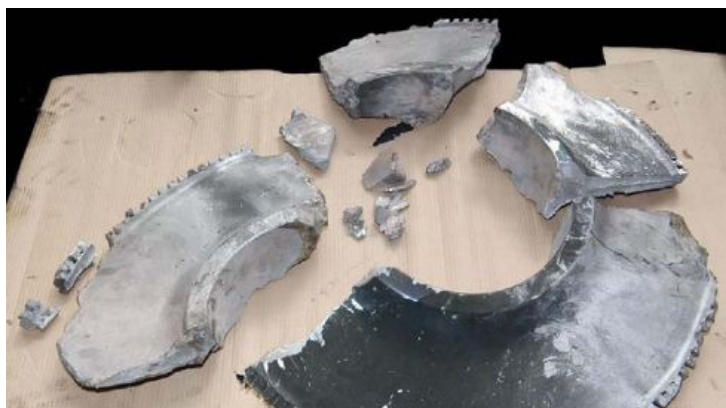
Fahrenheit, ignited in the 686- to 707-degree Fahrenheit buffer space. The ensuing fire damaged the HP turbine seal, and then continued with the direction of airflow, heating the drive arm. The IP turbine disc separated from the drive shaft and continued, uninhibited by the shaft, to accelerate from the ambient air flow, ultimately accelerating to the point of bursting. The fractured disc projected outward in three main pieces with enough force to breach the engine casing and damage the aircraft.

Figure 3. A Trent 900 IP turbine disc after an overspeed burst test. The disc that ruptured on Qantas Flight 32 broke into three main pieces and created holes in the port wing large enough for an adult to enter the wing. Source: Rolls-Royce plc./ATSB

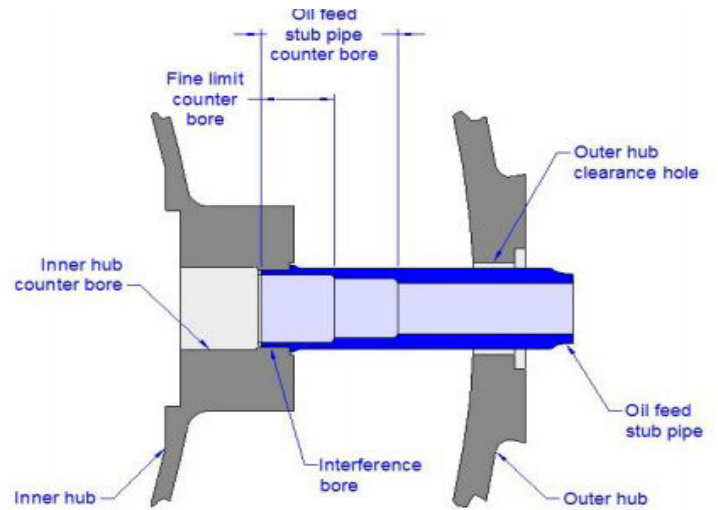
After thorough investigation, the ATSB determined that a fatigue crack developed in the No. 2 engine HP/IP oil feed stub pipe. Although it was not determined when the crack started, the crack grew enough to allow an atomized oil spray to leak out into a buffer space. The synthetic oil, with an auto-ignition point of 536 degrees

The ATSB found that the No. 2 Trent 972-84 engine oil feed stub pipe within the HP/IP hub assembly was manufactured with thin wall sections that did not conform to design specifications. The nonconforming thin pipe stressed and cracked under normal operating movement of the HP/IP hub. The oil feed stub pipe's reduced thickness was the result of a misaligned bore axis during manufacturing.

Figure 4. The oil feed stub pipe fits between the inner hub and outer hub of the IP/HP hub assembly. Source: ATSB.
